Detecting Gear Tooth Fracture in a High Contact Ratio Face Gear Mesh

Prepared for the 49th Meeting of the Society for Machinery Failure Prevention Technology cosponsored by the Vibration Institute, ONR, and ARL Virginia Beach, Virginia, April 18-20, 1995

DETECTING GEAR TOOTH FRACTURE IN A HIGH-CONTACT RATIO FACE GEAR MESH

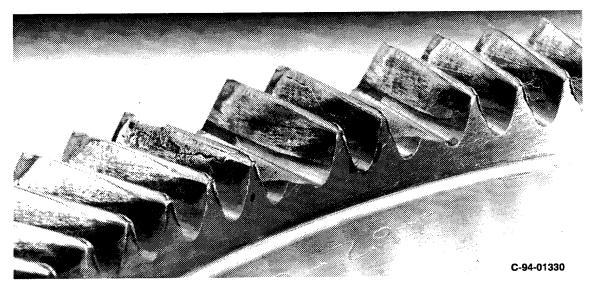
Figure 1 illustrates the tooth damage resulting from face gear run #1. During the last 7 hours of the test all of the teeth on the face gear experienced heavy wear damage, with some developing severe pitting and surface fatigue cracks as well. One tooth broke off at approximately 18 minutes before the end of the test, and the test was terminated when the second tooth broke off. Both were complete tooth fractures, as shown in the figure.

Figure 1.—Gear tooth damage at end of face gear run #1.

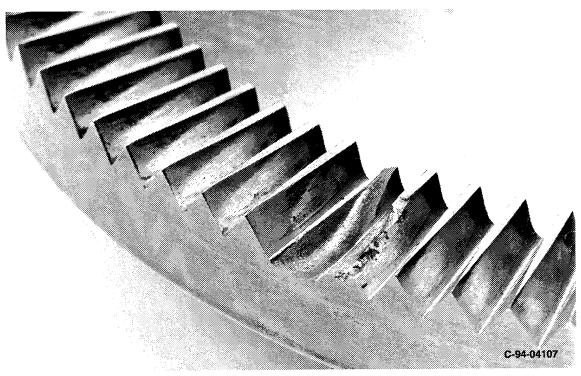
Figure 2 illustrates the damage resulting from face gear run #2. After about 25 hours into the run, the load was incrementally increased over a period of 5 hours to 200%. The test continued at 200% load until 3 teeth broke off. Almost one complete tooth broke off along with a majority of an adjacent tooth, as seen in this figure. The third tooth, positioned approximately 120 degrees from the two shown in figure 2, also experienced a partial tooth fracture of over 50% of the tooth.

Figure 2.—Gear tooth damage at end of face gear run #2.

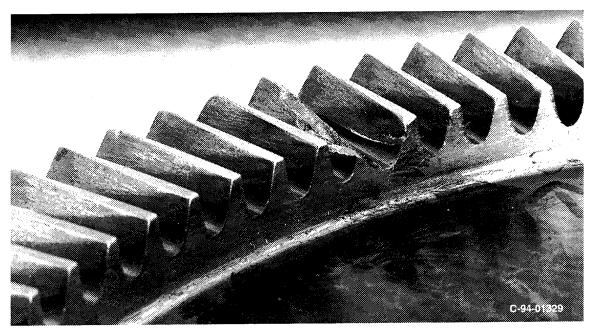
Figure 3 illustrates the tooth damage resulting from face gear run #3. During the last 3 hours of the run several teeth on the face gear experienced gradual pitting damage on the tooth surface. This resulted in the pitting-induced single tooth fracture at the end of the test. As seen in figure 3, nearly 75% of the tooth broke off. In addition, the tooth adjacent to the fractured tooth has extensive pitting damage, and a fatigue crack across most of the tooth width.

Figure 3.—Gear tooth damage at end of face gear run #3.

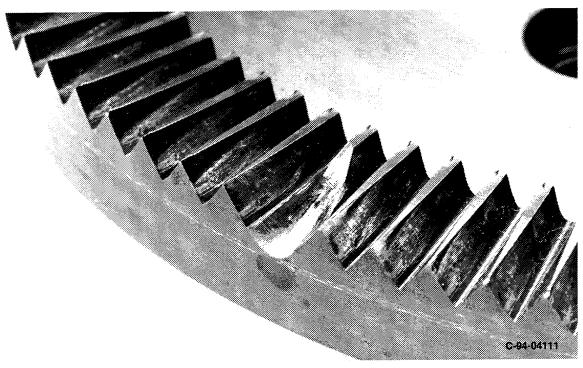
Figure 4 illustrates the damage resulting from face gear run #4. As seen in this figure, the damage was limited to a single tooth fracture. Approximately 75% of the tooth broke off during the test.

Figure 4.—Gear tooth damage at end of face gear run #4.

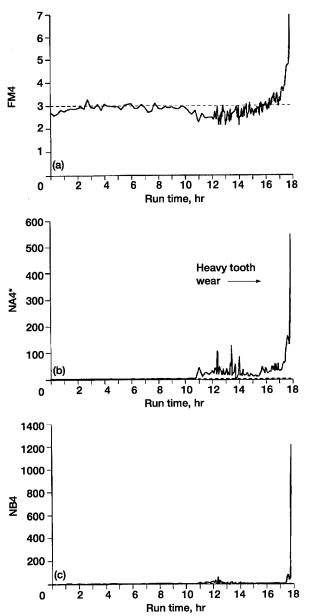
Based on the results, all of the gear diagnostic methods investigated reacted significantly to the multiple tooth fracture damage experienced in face gear runs #1 and 2. As seen in figure 5, all of the parameters clearly indicated the multiple tooth fracture damage at the end of run #1. One tooth, or a portion of a tooth, broke off at approximately 18 minutes before the end of the test, which may account for the "knee" seen in the resulting plots at approximately the same point in time. Table 1 lists the results of the methods for the last 30 minutes of run #1. From the graphs in figure 5, it appears that the indications from the methods are nearly instantaneous. However, as seen in table 1 there is a gradual increase in FM4, NA4*, and NB4 over the last 24 minutes. At the end of run #1, FM4 reaches a value of 7.0, NA4* reaches 549, and NB4 reaches 1213, all relative to the nominal value of 3.0. Similarly, as seen in figure 6, all of the parameters clearly reflect the multiple tooth fracture damage at the end of run #2. Table 2 lists the results of the methods for the last 24 minutes of run #2. Again, the damage indications from the methods are not instantaneous, but gradually increases over the last 21 minutes of the test. As seen in this table, at the end of run #2, FM4 reaches a value of 6.7, NA4* reaches a value of 142, and NB4 reaches a value of 369.

Method NA4* was able to detect more than just pitting and tooth fracture damage. As seen in figure 5b, only NA4* reacted significantly to the heavy wear damage experienced by the face gear during the last 7 hours of face gear run #1. As in previous tests [2,3], NA4* was shown to be capable of reacting to a number of different failure modes. In these series of face gear tests, NA4* was able to detect gear tooth pitting, heavy wear, and fracture damage. NA4* is however, sensitive to load and speed changes. For example, as the load was gradually changed from 100% to 200% of design load between the run time of 26 and 31 hours during run #2, NA4* gave a false indication of damage, as seen in figure 6b. These false reactions by NA4*, in this case, are much lower in magnitude than its reaction to the actual tooth fracture damage at the end of run #2.

Although method NB4 gave no reaction to the runs with single tooth damage, it did give the most robust reaction to the runs with multiple tooth fracture damage (runs #1 and 2). As seen in figure 5c and table 1, NB4 stays near the nominal value of 3.0 until near the end of run #1, where NB4 increases to over 400 times the nominal value. Similarly, as seen in figure 6 and table 2, NB4 stays relatively close to the nominal value until near the end of run #2, where NB4 increases to over 120 times the nominal value. In addition, NB4 does not appear to be as sensitive to load and speed changes as method NA4*.

Figure 5.—Face gear run #1 results. (a) FM4. (b) NA4*. (c) NB4.

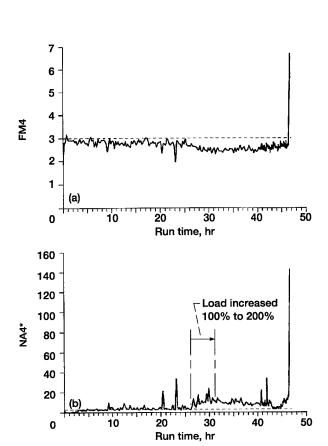
Figure 6.—Face gear run #2 results. (a) FM4. (b) NA4*. (c) NB4.

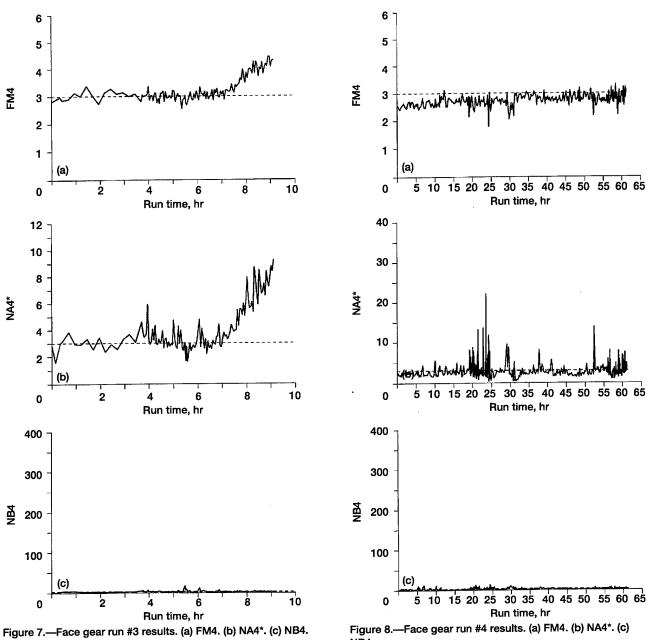
Single tooth damage, as experienced in face gear runs #3 and 4, was more difficult to detect using the methods investigated. As seen in figure 7, only FM4 and NA4* reacted to the gradual pitting damage and single tooth fracture experienced in run #3. The final values of these two parameters are much lower than that experienced in the runs with multiple tooth fracture damage. NB4 did not show any indications of the damage in this run. As seen in figure 8, none of the parameters give any indications of the single tooth fracture damage experienced in run #4. For both run #3 and run #4, the tooth fracture damage was similar, i.e. approximately 3/4 of one tooth broke off, however only run #3 had some damage detection success. This may be due to the fact that the tooth adjacent to the fractured tooth in face gear run #3 had extensive pitting damage and a large fatigue crack. Even though this adjacent tooth did not break off in run #3, it was damaged enough to act similarly as if it were partially fractured.

Figure 8.—Face gear run #4 results. (a) FM4. (b) NA4*. (c) NB4.
